ALL SAINTS CHURCH

BUILDING AND GROUNDS CAMPAIGN

Caring for God's Church

2015-2016

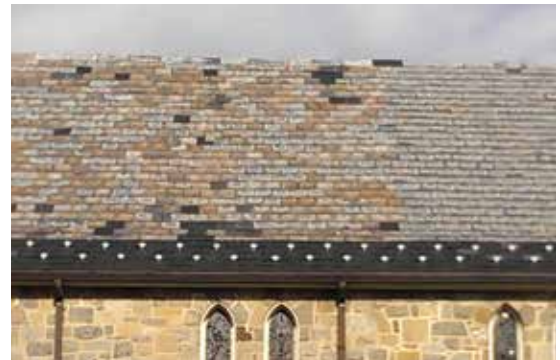
Nave Slate Roof

Most of the slate on the roof over the Nave and Chancel dates back to their construction between 1923 and 1925. Two differing qualities of slate were used on the roof. You can see the difference with the naked eye. The front of the Nave is a darker, higher quality slate. The second half shows what happens when you cut quality in order to cut costs. While the slates in the Western portion are more deteriorated, both sections desperately need to be replaced.

Slate roofs ordinarily have a maximum life of about 50 years - which means that we have exceeded our grace period by almost twice that time. Since their installation, the slates have delaminated and discolored. Delamination is a mode of failure for composite materials. In laminated or layered materials like slate, repeated cyclic stresses impact the slate and can cause layers to separate, becoming mica-like and then can separate and chip off in layers.

Our slates break off at an increasing rate. Recently, daylight could be seen through the Chancel roof peak because of such breakage. You can see where numerous repairs have already been made. These are a constant factor in the annual building and grounds expenses.

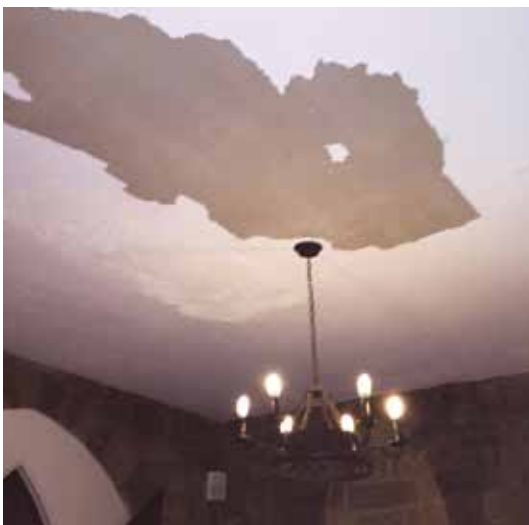
Bride's Room Ceiling

Roof leaks have also have resulted in substantial repair expenditures each year. This year, the flat roof over the Sacristy and Circle exit door has begun to leak into the exit door foyer. The slanted tin roof area over the Bride's room, the flat roof over the hallway north of the Bride's room, and the roof over the stairwell to the Oliver Street exit, also leak into the interior of the Church.

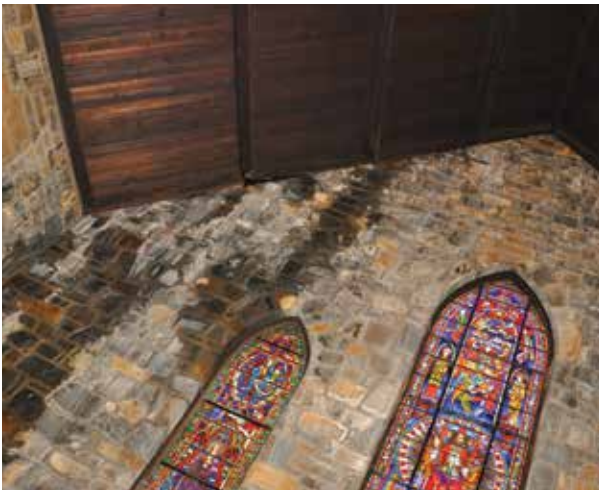
Nave West Wall Water Damage

Related to this issue is the fact that, as long as anyone can remember, rain water has passed inside and down the West wall of the Nave. Joe Alonso, of the Cathedral, and one of his roofers, Joe Skillman, both feel that much of the leakage stems from a breakdown of the water barriers, flashing, counter flashing, and felt roof covering between the roof decking and the capstones of the West wall.

When strong West winds drive heavy and sustained rain onto the West wall of the Nave, water emerges from the inside of the wall in spots below the rafters; such as on the South wall abutments. This is causing the mortar to break down and crumble off the wall. Grit fallen from the wall and ceiling are a continuous presence on the back pews, and the magnificent stained glass windows are being made vulnerable by the deterioration of their frames.

The water damage along the West wall may be caused by the leaking roof where water passes inside the wall from above and emerges further down. It might also be caused by water leaching straight through the wall, or it could be a combination of the two.

If, after the roof project is done, water continues to pass through the wall, the problem is obviously coming from a different source, and two steps will be taken. First, the avenues through which the water passes from the outside will be pinpointed. This would be accomplished by a water penetration study of the West wall. Second, the study may show the capstones on the wall have to be removed and the flashing, if any, on the wall inspected for possible leaks. It is possible that only a small area of the West Wall will need to be repointed, but it is entirely likely that the whole exterior wall would need to be done.

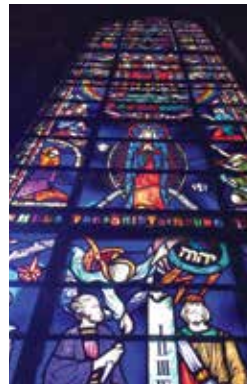
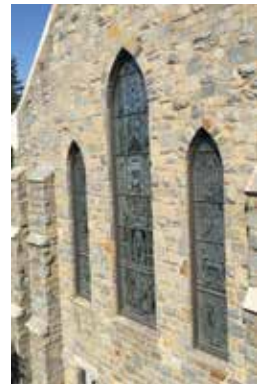
Interior and Exterior Nave West Wall and Stained Glass Windows

In heavy rains, water leaks through the exterior framing of the magnificent stained glass windows which are set in the West wall. Some external wood trim is visibly deteriorated and pock marked. One ventilator window panel does not seal and lock. We will use the company that has previously cared for and repaired our windows, Epiphany Studios, for the necessary repairs.

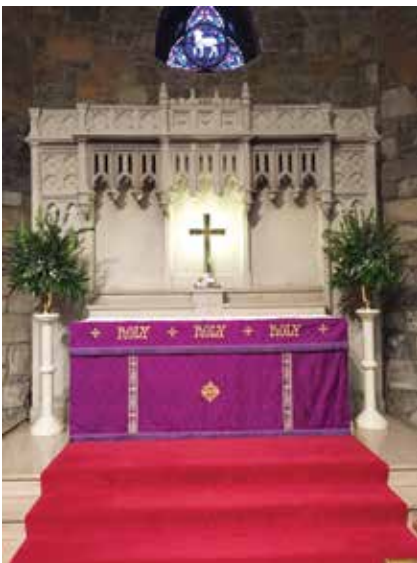
Chancel Altar Reredos

Another major issue in this space is the candle soot which has been building up for years defaces the Sanctuary Reredos, making it quite dirty and unattractive. Reredos is the name given to the structure behind an altar. It can be decorative with religious depictions, or as in our case, quite plain and simple. Unfortunately, this simplicity makes the dirt even more obvious. This Reredos cannot be simply washed off because it is made of limestone, which absorbs water. This cleaning requires an extraction technique called poulticing.

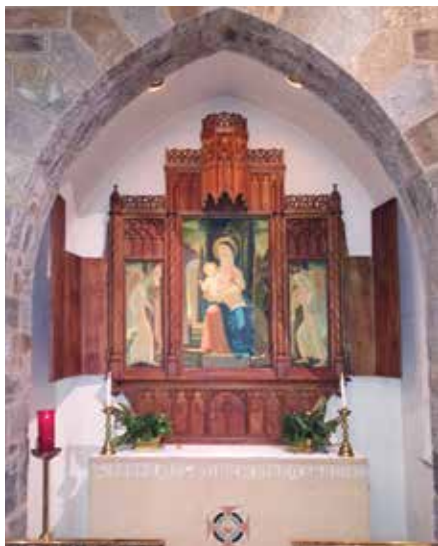
St. Mary's Chapel

The art in All Saints two chapels is both beautiful and valuable, and it needs to be preserved and displayed for the congregation, and to the glory of God.

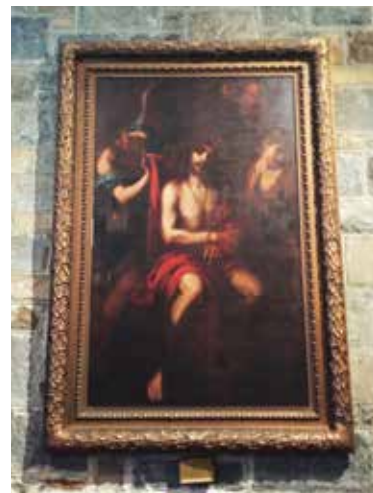
*St. Joseph's Chapel
Fine Art Restoration*

The two paintings in St. Joseph's Chapel require cleaning. Both paintings were varnished, as was the custom "back in the day." Varnish yellows and cracks with time, causing the paintings to become difficult to see and appreciate. Dirt and soot has added to the problem. The painting "After the Scourging" is the more valuable of the two paintings, but is very dark and difficult to see.

Removing the varnish and cleaning the artwork should help to bring out the rich detail. Both paintings will be illuminated by energy efficient focal lighting and digital controls. In addition, a portion of the plaster crown molding in St. Joseph's Chapel has fallen and will be reattached.

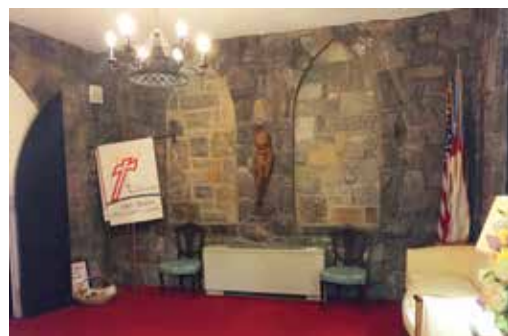
Interior Bride's Room

The Bride's Room has not been updated since the 1950's. This room is not just for brides. It is where the choir, Lay Eucharistic Ministers, acolytes, and ministers congregate before the service. The furniture and fabrics and, particularly, the lighting are badly suited to the functions of the room and require thoughtful redesign.

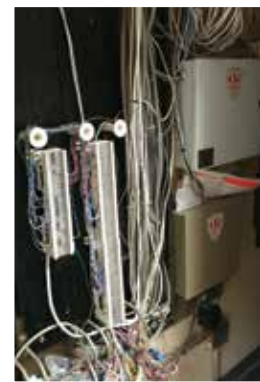
Outdated Wiring, Phone Circuitry and Breaker Panels

The electrical circuitry in the Church dates from when All Saints was first built. Various versions of the Church electrical circuitry were added as the Church building was expanded during the mid-1920s, 1954, and again in 2000. However, we only have the latest installation of circuitry plotted and documented.

In addition, our electric breaker panels (12) have not been tested for loose wires, competency of breakers and circuits, and other fire hazards. These will be tested, and a reserve for corrective actions is provided.

The descriptions on the breakers panels are opaque in most cases. To correct this each circuit throughout the Church will be traced and named, and each panel and breaker properly labeled, using a unitary labeling system.

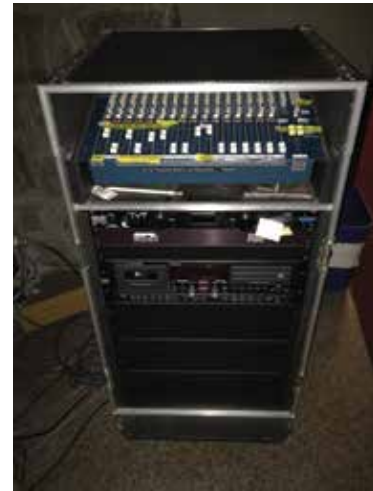
Nave Audio System

The desk will house the devices which record, process, and transmit digital audio and video media. The video cameras will be turned off and on remotely and will have remote panning and range finding controls. The controls will have presets for set conditions of use, so that an operator will not be required to be stationed in the booth throughout the event or service.

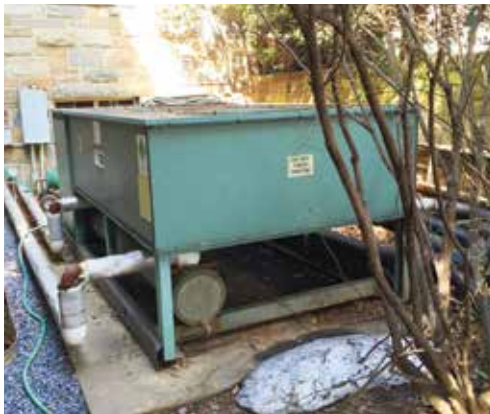
1950s HVAC System

Underneath the great stone walls and floor of All Saints lies a huge heating and cooling, (HVAC), infrastructure. This Church equipment dates from 1993. Since then, corrosion, leakage, power outages, breakdowns, obsolescence, and just plain inattention, have caused deterioration in these essential facilities.

The Church's HVAC control software, and the machinery-regulating controllers in the various machinery spaces, are quite dated, are breaking down, and/or are no longer serviced. Breakdowns or outages, particularly at odd hours, are a terrific burden on Staff and require significant ad hoc expenditures not contemplated in the operating budgets from year to year. These, plus electrical, gas, and water services consumed by these dated systems, are a significant proportion of our annual operating budget.

Modern HVAC systems, right-sized for the building, will address these issues and greatly reduce the annual expense of heating and cooling the Church. The Church will commission a professional analysis of the most durable and energy-efficient heating, cooling, and software and controller systems the Church might acquire in the future, and of when that will be necessary. This can be acquired free from a professional mechanical company(s) if we engage them to perform regular, routine, preventive maintenance on our systems. We pay more for these seasonal measures now than we would under contracts.

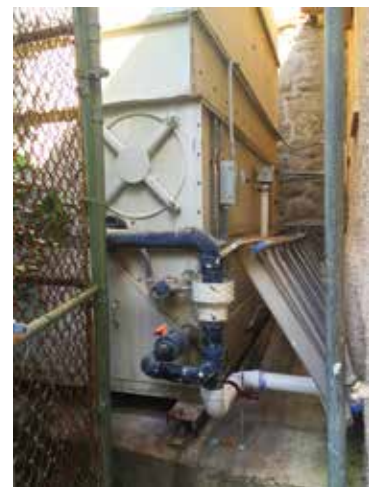
Cooling Tower

Since 2010, we have made numerous improvements to the chiller systems and the cooling tower. However, coolant used in the giant air conditioning "chiller" will be out of compliance with law in a few years.

Water entering the Church through its main meter is subsequently lost at the cooling tower, either to evaporation or leaks from the tower. While that lost water never passes into the sewer, WSSC levies a sewer charge as if it did. However, if we install a water sub meter on the chiller water supply line, WSSC will grant a 60 + percent credit against sewer charges on that flow.

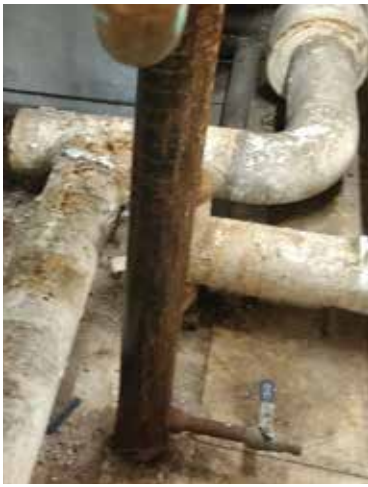
Heating Plumbing Pipes

In the winter of 2014-2015, our heating system developed many extraordinary problems. The original lead-lag controls on the two boilers have not worked since installed. Therefore, the run times of each boiler have not been balanced with the other. Moreover, we found that we had no controls which cut back boiler water temperature, and thus, boiler fuel consumption, when outside temperature conditions warrant it.

We are in process of installing an outside air temperature sensor and an inside lead/lag switch. These devices will shift lead and lag boilers automatically on a set rotation, and they will cut back minimum boiler water heat requirements on warmer days. Recently, we had to replace the speed controller for the hot water circulating pump.

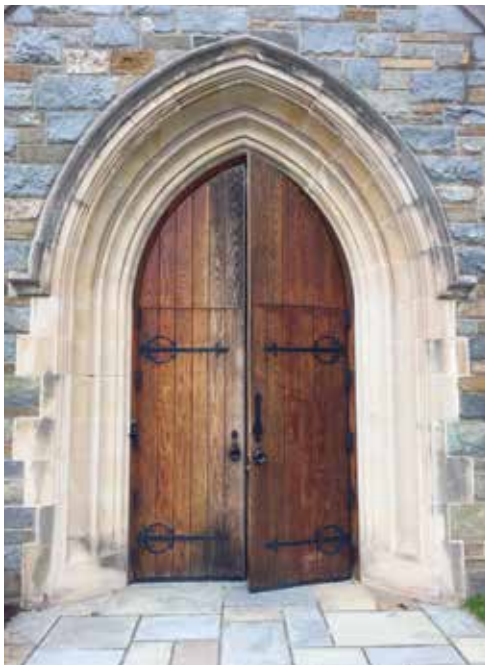
Western Avenue Wood Doors

The Narthex exterior doors are disintegrating and unsightly. They are badly in need of carpentry work,

staining, and refinishing with durable varnish. While they are removed for this work, either temporary doors or a night watchman or both will be needed. And, the Narthex floor tiles require stripping and recoating.

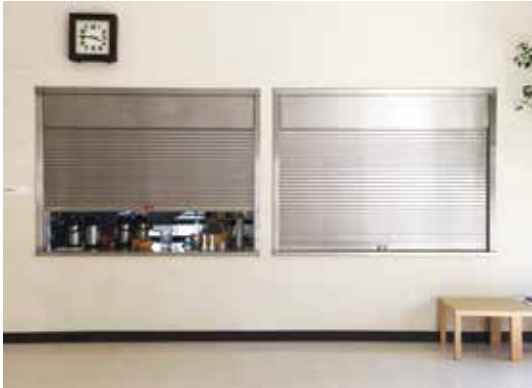
However, the Great Hall is not an attractive space. Its décor is drab and plain, the walls and windows are very “institutional” and uninviting, and the kitchen pass-through windows are a visual intrusion, even when closed. The Great Hall walls will be covered and the windows reframed in a Church-appropriate design. Both kitchen openings will be de-emphasized visually.

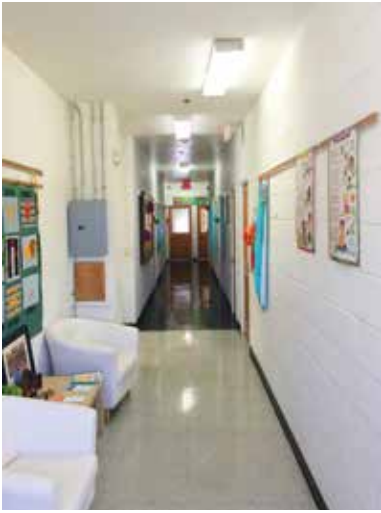
Second Floor Parish House

However, the corridors on the second floor are dimly lit, and the concrete block walls in the corridor and rooms are forbidding and cold. They have remained so since the Parish House was built in 1954. This cheerless environment is not conducive atmosphere for awakening

young minds to an exploration of faith. New lighting, carpeting, and wall coverings will create a more appropriate environment. Heating will be addressed as well.

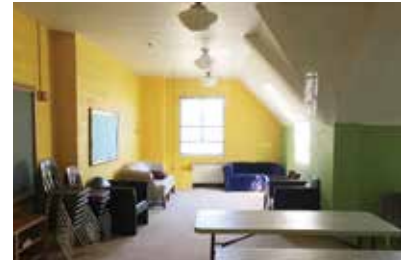
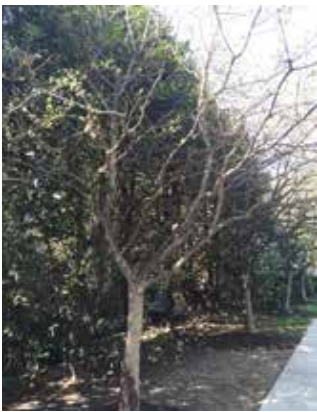
Grounds and Plantings

On the main entrance way, trees have overgrown the space available and certain shrubs, bushes and trees have died. Trimming or replacement is required.

In addition, the soil under and the yew bushes in the hedge, east of the main entryway, is infected, causing many yews to die. These need replacing. The area of grass between the playground and the Youth Room will be re-landscaped.
